123 Ave, Anywhere, TX  
Inspection prepared for: Sample Sample  
Date of Inspection: 10/8/2020 Time: 8:00 AM  
Age of Home: 1987 Size: 1731

## PROPERTY INSPECTION REPORT

Concerning: 123 Ave, Anywhere, TX  
(Address or Other Identification of Inspected Property)

By: Lou Wissner, License #7492 10/8/2020  
(Name and License Number of Inspector) (Date)

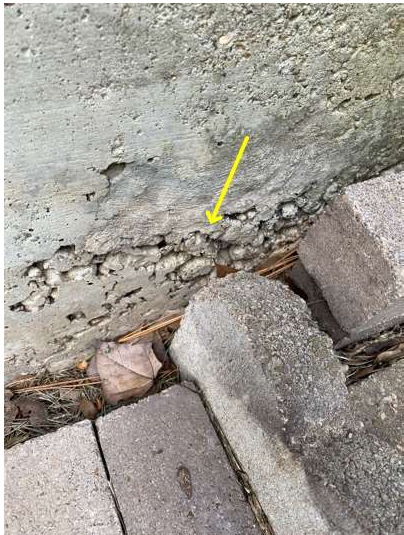
- Honeycombing was noted in several locations of the foundation. This is mostly a cosmetic condition that is found only upon the exterior face of the home's foundation. Recommended to thoroughly clean the area to remove all dirt and loose aggregate, wet the cleaned area prior to applying non-shrink grout, texture and color should then be matched for aesthetic finish.

Honeycombing

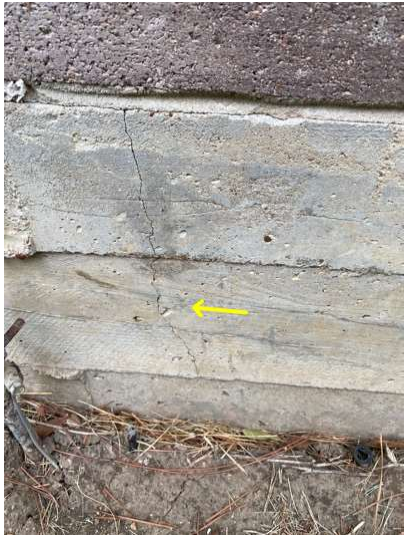
- Hairline cracks were observed in the foundation slab of the house. These are not uncommon, where under 1/4 inch wide and should be monitored.
- Significant deviation in foundation when foundation level survey was performed; up to 3.7 inch. There was also one rafter splitting. It is recommended to be reviewed and further evaluated by a qualified licensed structural engineer.

Hairline crack

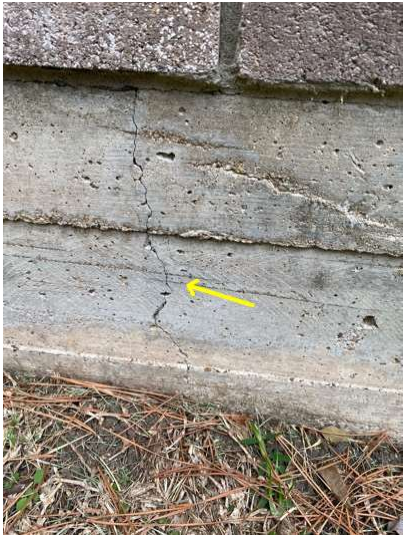
Hairline crack

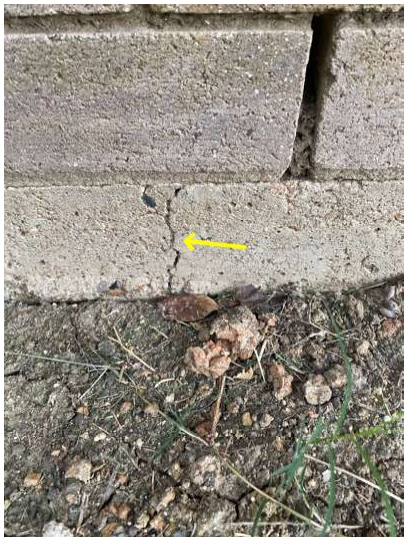
Cracked

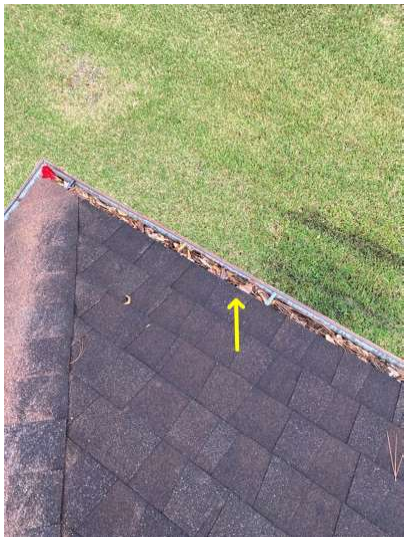
- Gutters are partially restricted with debris which could allow runoff to back up into structure. It is recommended to periodically clean gutters to prevent restrictions.

*Debris*

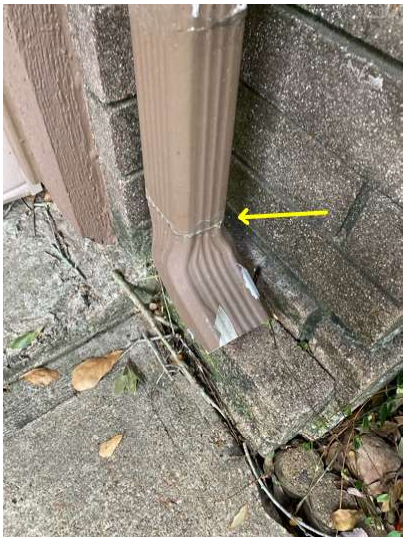
- Gutters are loosely attached, damaged or missing in several locations, allowing water to be redirected onto residence. It is recommended to be properly repaired or replaced to allow for proper drainage.

*Loosely attached and damaged*

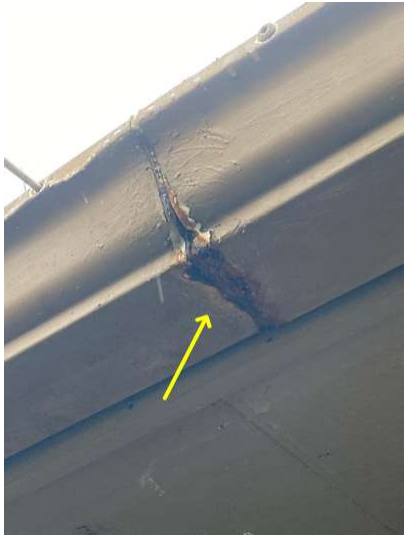
- Downspout damaged and or loose in several locations. It is recommended to properly repair or replace as needed to ensure that rainwater will discharge and be directed away from the foundation.

*Damaged*

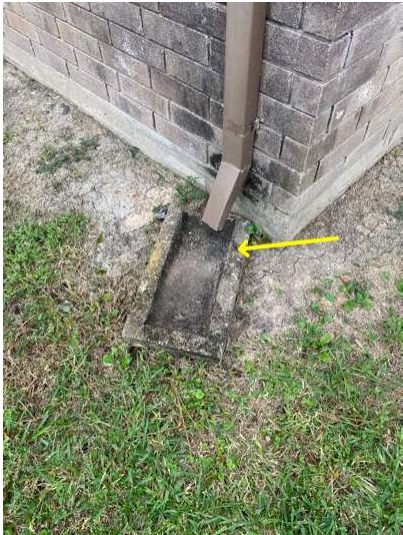
- Gutter downspout splash block is missing or misaligned in several locations. It is recommended to properly install to prevent erosion around foundation.

*Misaligned*

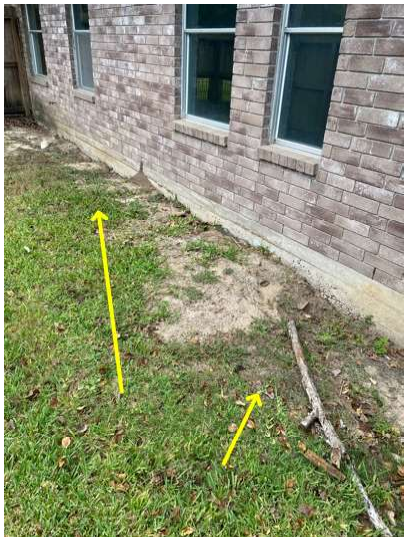
- Ground erosion at Right side of residence due to run off of roof. It is recommended to have gutters and downspouts installed to prevent further erosion which can lead to foundation concerns.

Erosion

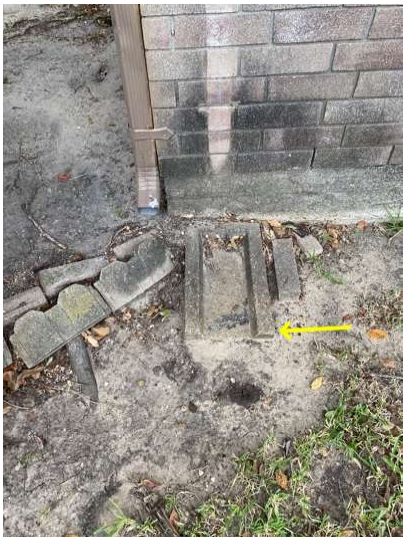
Misaligned

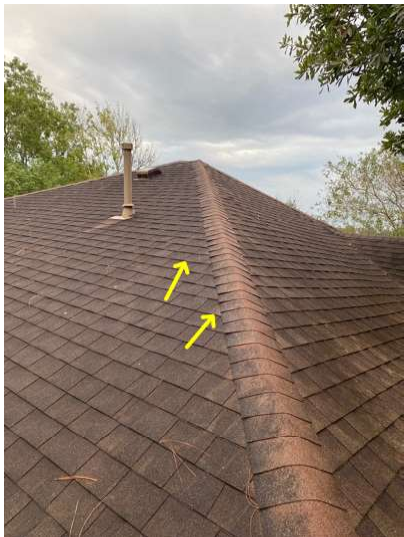
- Roofing Nails have popped loose or have backed out in several areas. It is recommended to fully drive nails and apply a small amount of roofing cement to prevent moisture penetration and premature failure.

*Nail pops*

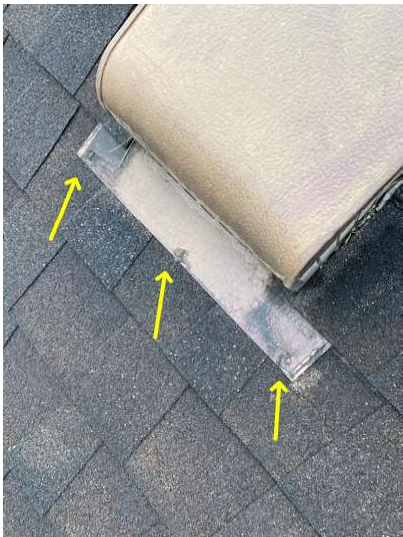
- Exposed nail heads in multiple locations of roof. These will rust in time, which can lead to water penetration. It is recommended to be properly cleaned, primed, and painted as needed.

*Exposed nails*

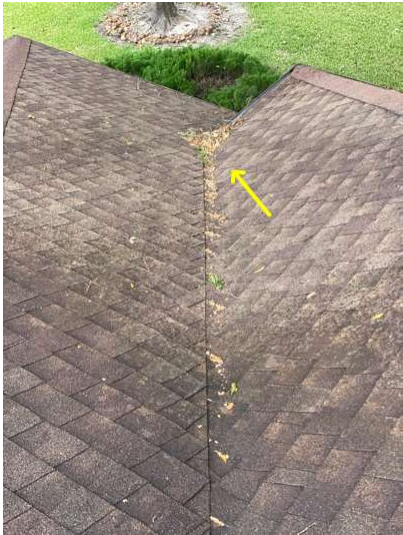
*Debris*

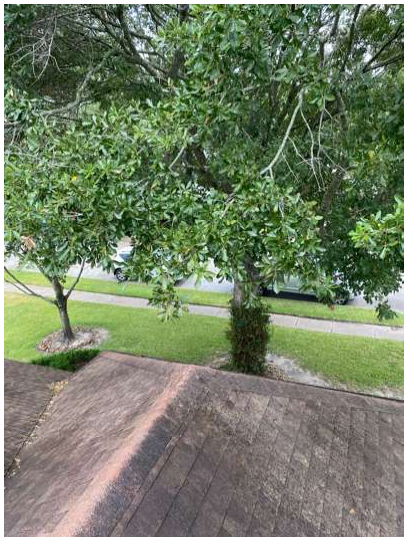
- Tree limbs in several areas of residence have come into contact with the roofing material, fascia, soffits, and exterior walls. These will need to be maintained to prevent further damage. No evidence of water penetration. It is recommended to repair or replace all effected shingles as needed.

*Trees too close*

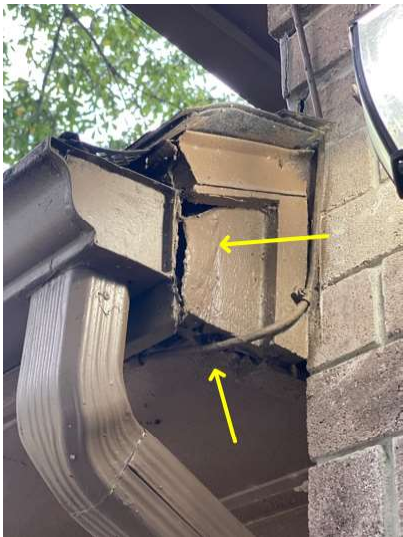
- Wood deterioration noted on fascia and soffits at several locations. It is recommended to properly repair or replace all affected material as well as caulk, prime and paint as needed.

*Wood deterioration*

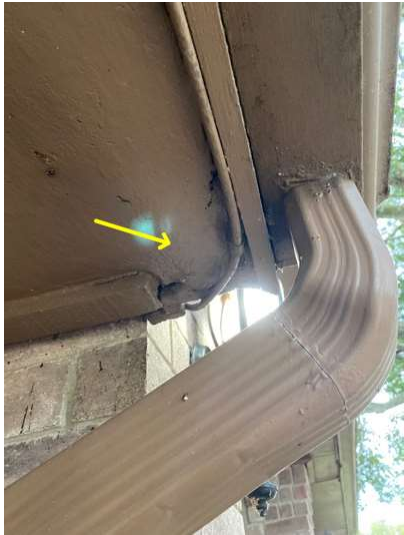
*Wood deterioration*

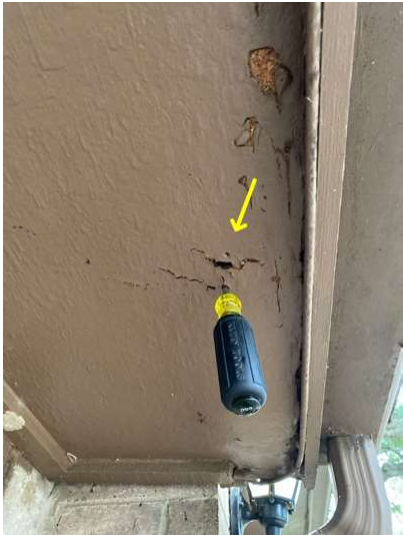
*Wood deterioration*

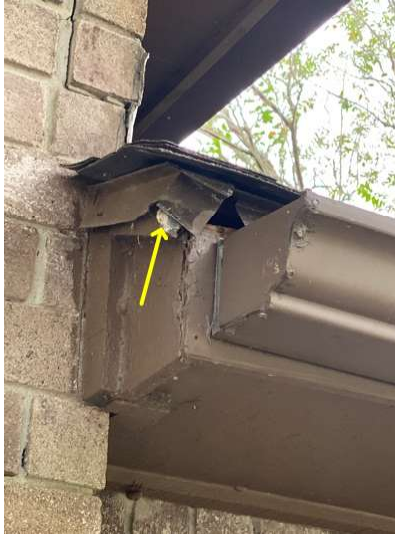
- Debris and limbs noted in several locations of roof. Accumulation can promote moisture penetration. It is recommended to be cleaned frequently.
- Drip edge flashing bent/loose/missing in several locations. It is recommended to be properly attached and sealed as needed.

*Damaged drip flashing*

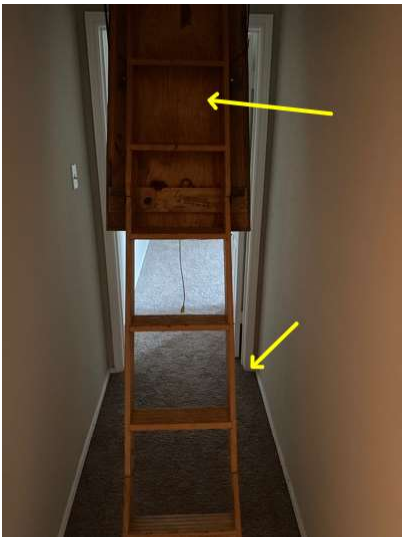
*Loosely attached ladder and no insulation*

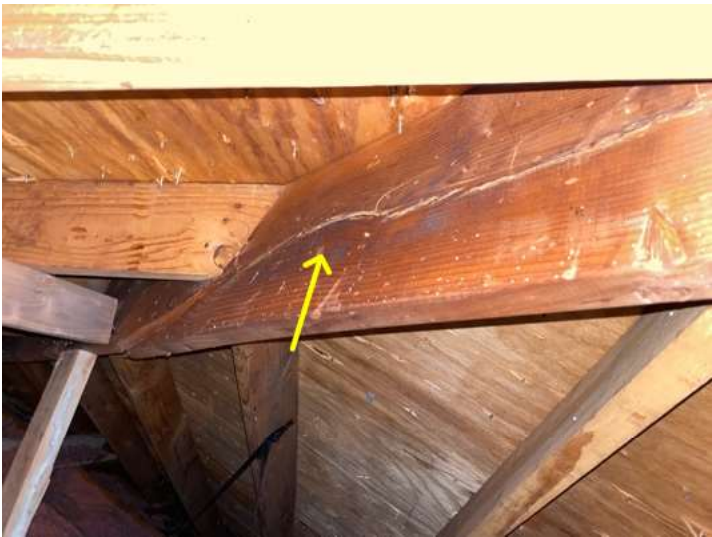
- Split structural member (rafter and ridge beam) in attic, noted in several locations. It is recommended to sister an equally sized dimension lumber at least 2ft beyond split to each rafter as needed.
- Exposed wiring in attic space. It is recommended to be properly repaired and secured in junction box by licensed electrician.
- Attic access ladder door will not close properly, ladder is loosely attached, attic door is not insulated. It is recommended to properly secure ladder and adjust door and hardware, install insulation to door and seal as needed or replace unit.

*Spilt rafter*

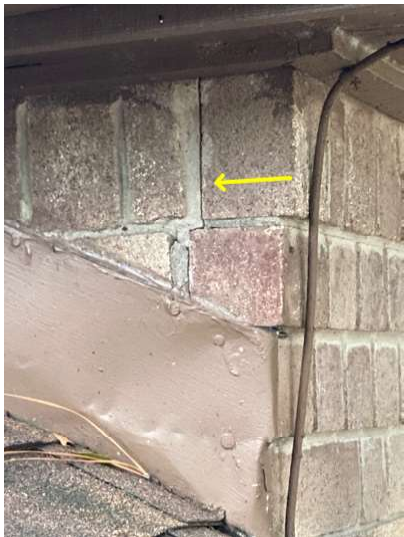
Cracks

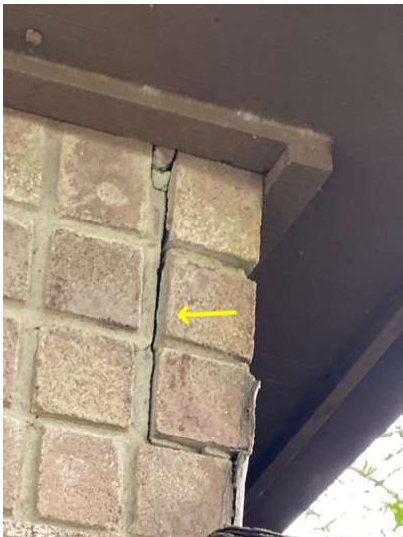
Cracks

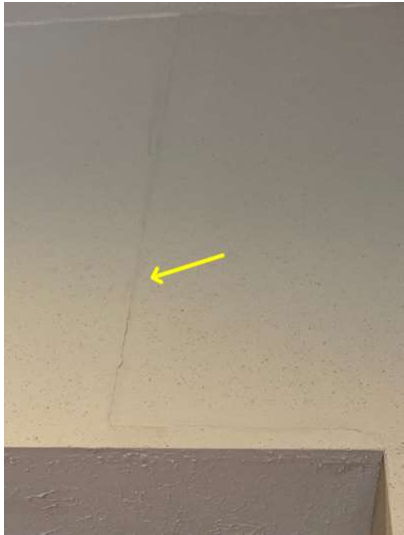
Crack - living room

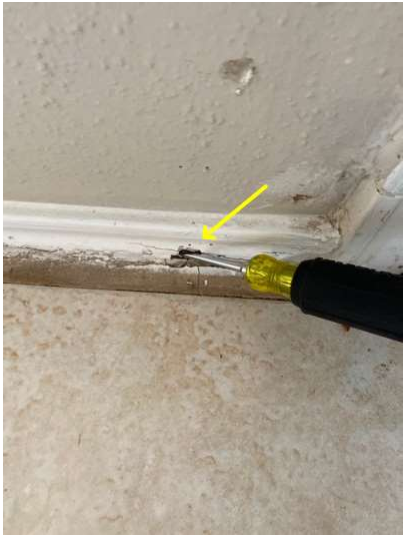
Wood deterioration - baseboard by back door

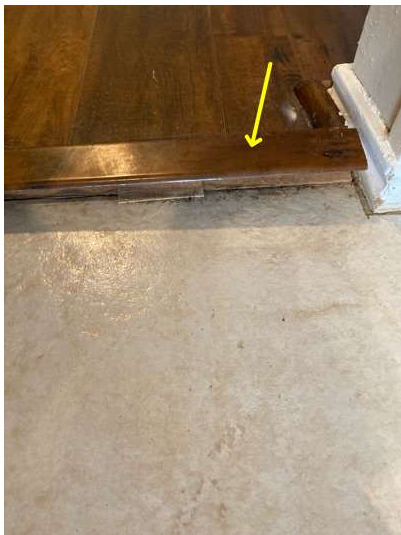
- Wooden transition trim between wood and adjacent flooring is loosely attached. It is recommended to be properly and securely attached as needed.
- Ceramic tiles cracked in several locations; bathroom, kitchen. It is recommended to be properly replaced as needed.

*Loosely attached*

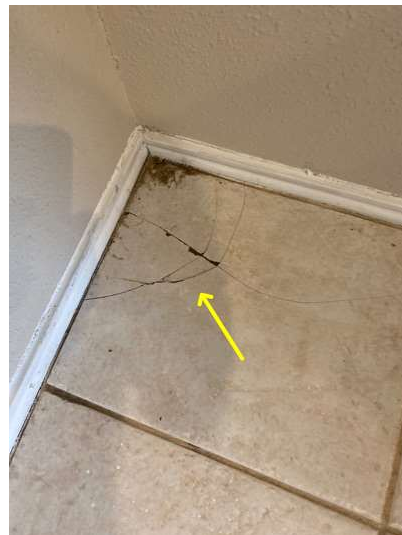
*Cracked tile - kitchen*

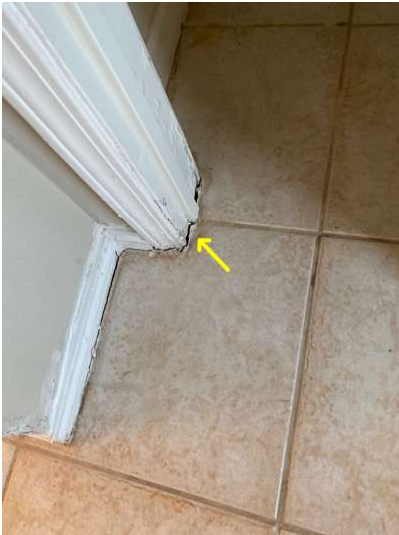
Caulking separation - Bathroom #2

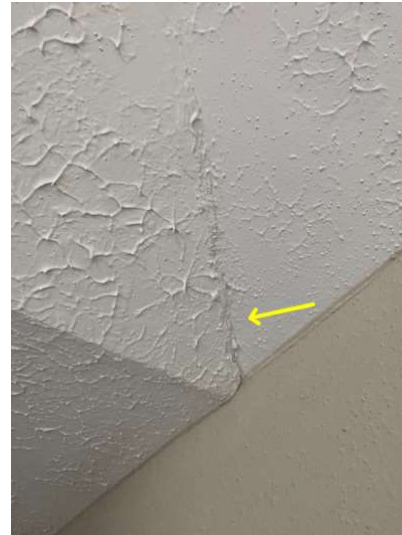
Cracks

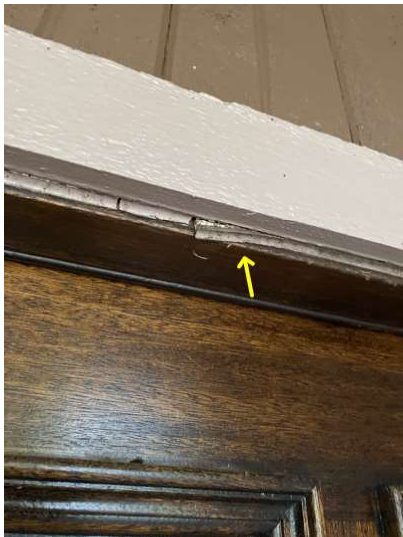
*Caulking deterioration*

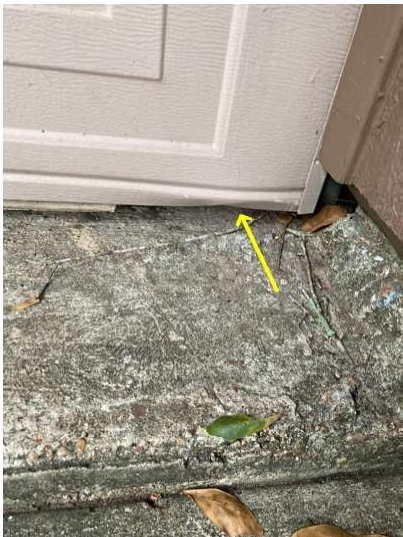
*Damaged weather stripping*

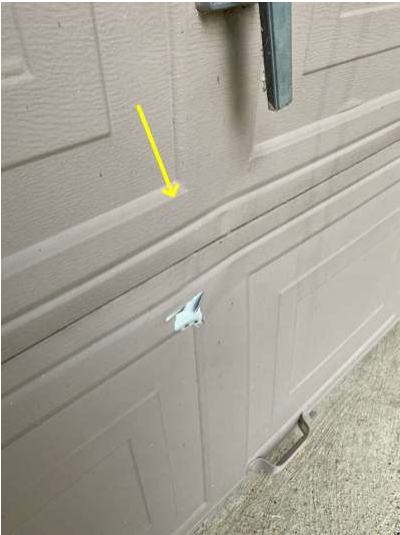
*Dented and paint peeling - garage door*

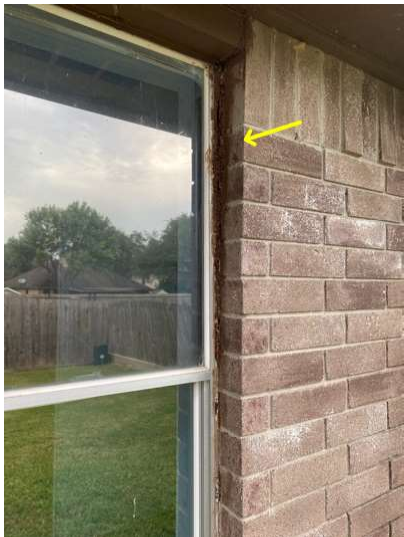
Caulking deterioration

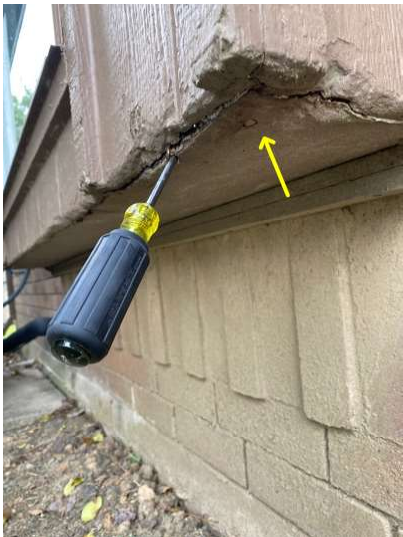
Wood deterioration

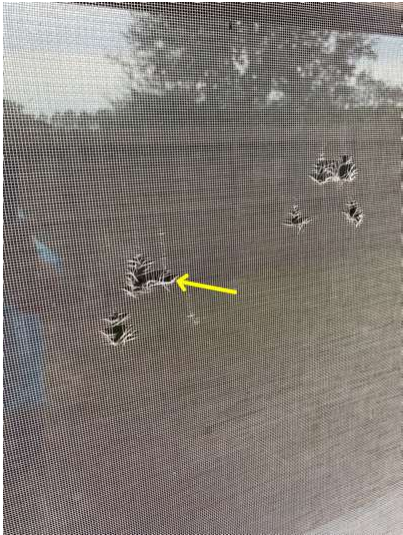
Damaged screens

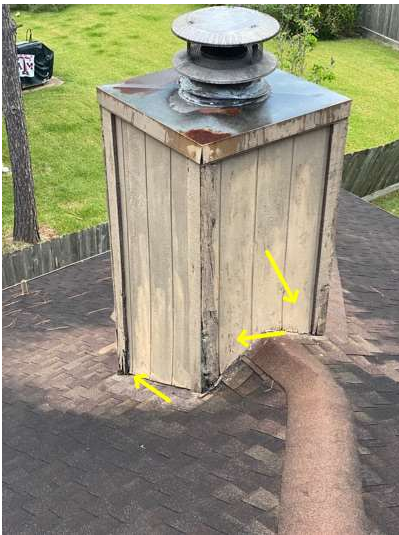
*Wood deterioration*

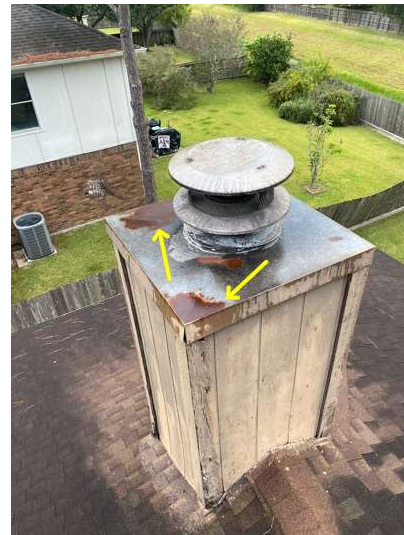
*Rusted cap*

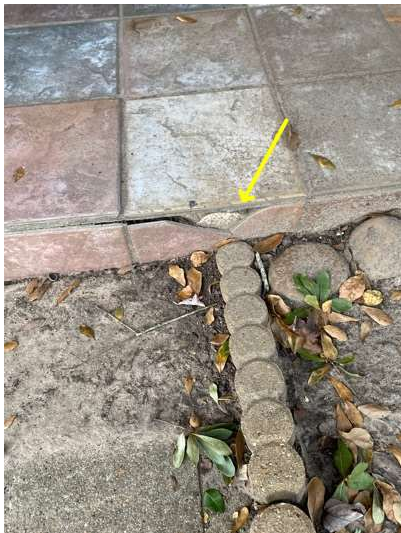
- Back porch slab is cracked. It is recommended to be properly repaired or replaced as needed.
- Front porch tile is broken. It is recommended to be properly repaired or replaced as needed.

*Damaged*

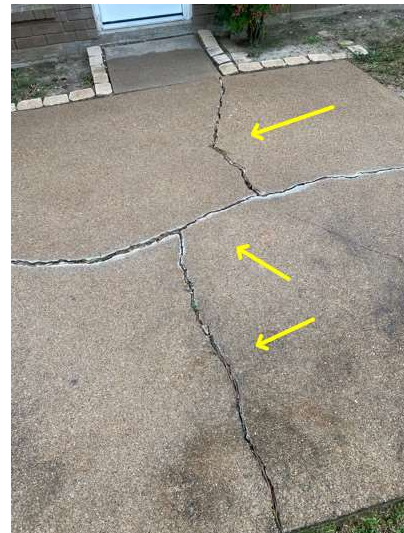
*Cracked*

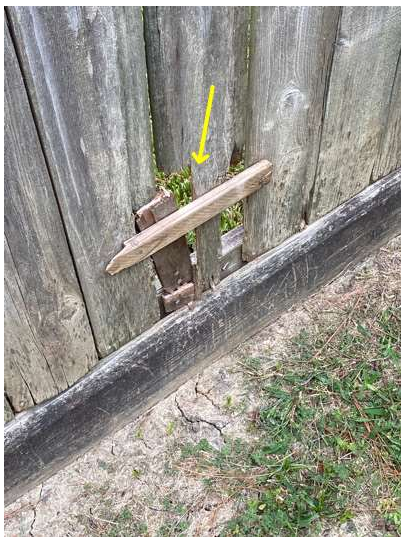
*Damaged*

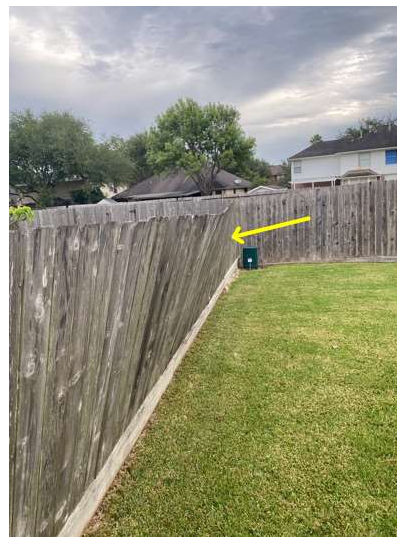
*Leaning***II. ELECTRICAL SYSTEMS**

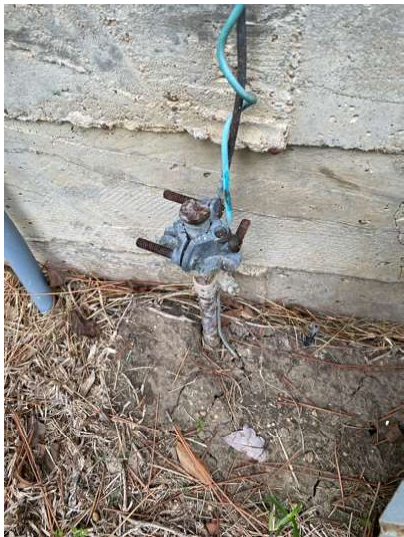
*Loosely attached*

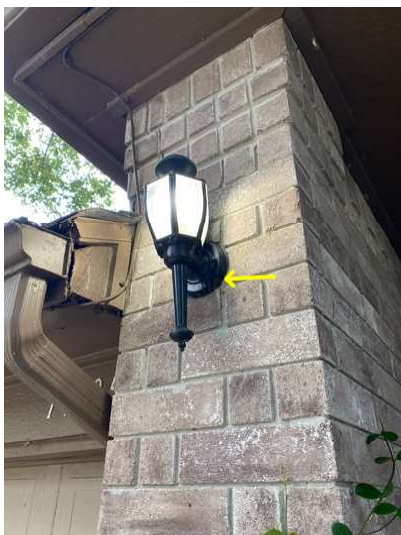
*Loosely attached*

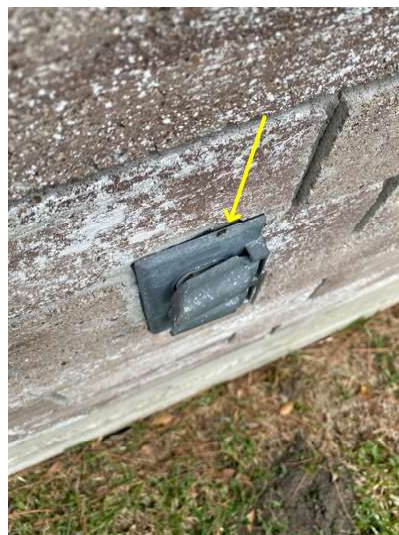
*Loosely attached*

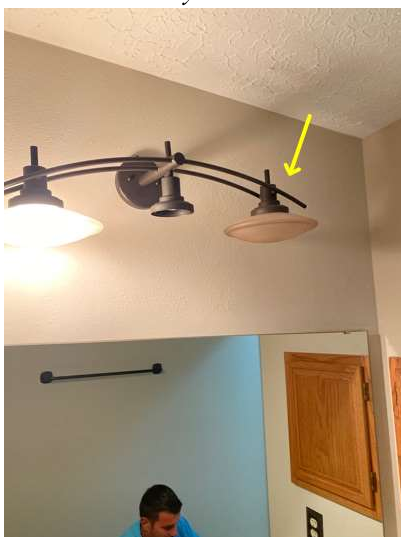
- GFCI plug will not reset in bathroom #1. It is recommended to be evaluated by a licensed electrician.
- Light in bathroom #1 is inoperable at time of inspection. It is recommended to be evaluated by a licensed electrician.

*Inoperable*

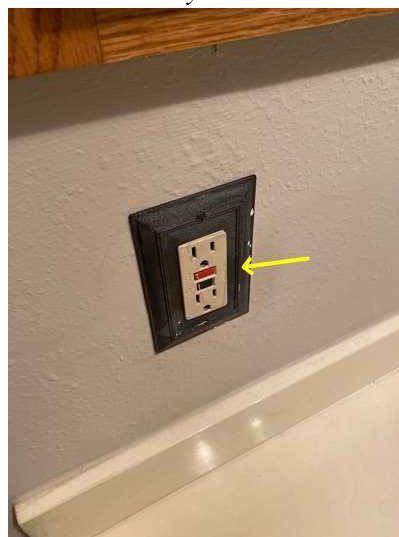
*Will not reset - bathroom #1*

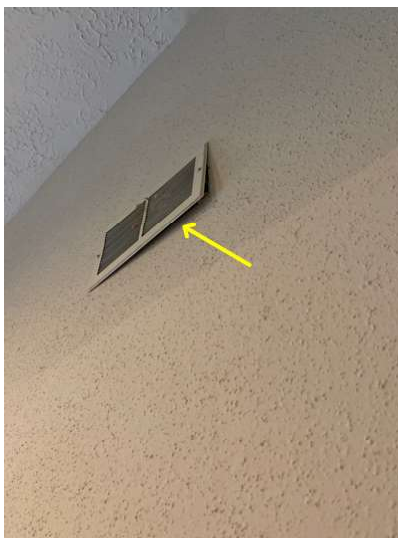
*Loosely attached - living room*

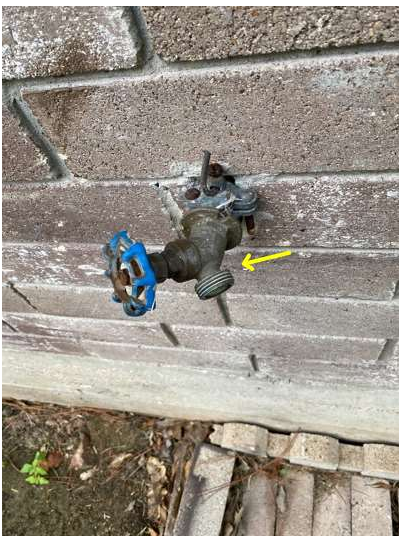
*Missing anti-siphon*

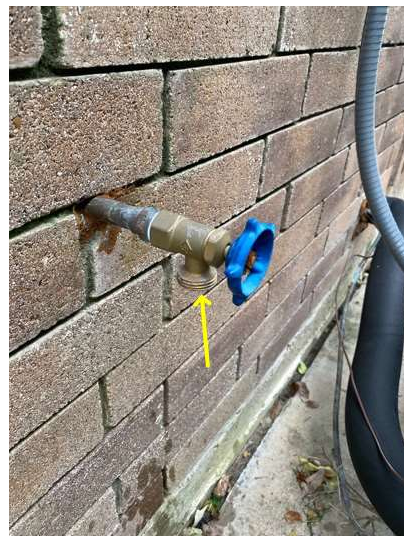
*Missing anti-siphon*

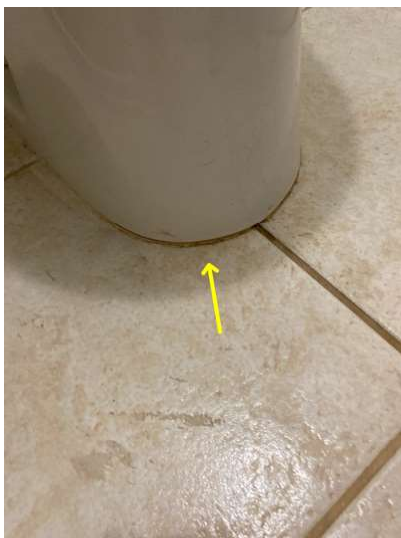
*Caulking deterioration*

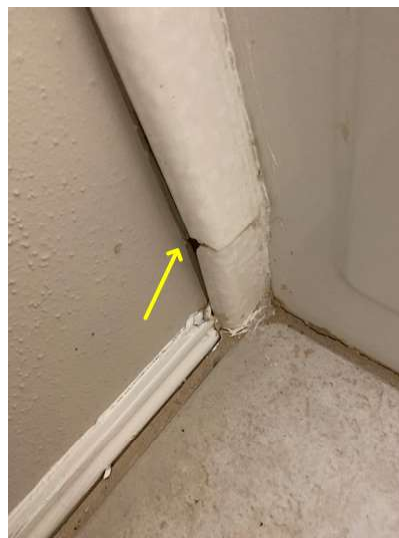
*Damaged / pulling up - bathroom #1*

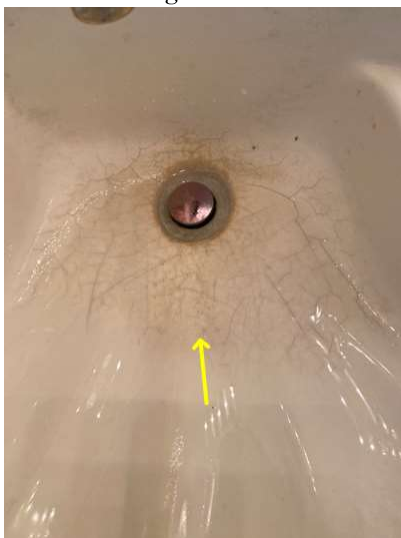
*Spidering - bathroom #1*

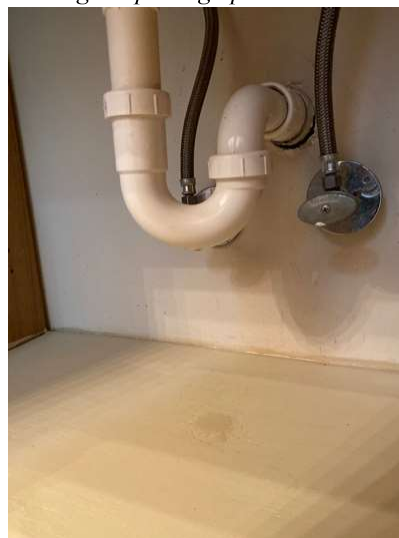
- Water leak under right sink in bathroom #2. It is recommended to be evaluated by a licensed plumber.
- Tub is slow to drain in bathroom #2. It is recommended to be evaluated by a licensed plumber.

*Water leak - bathroom #2*

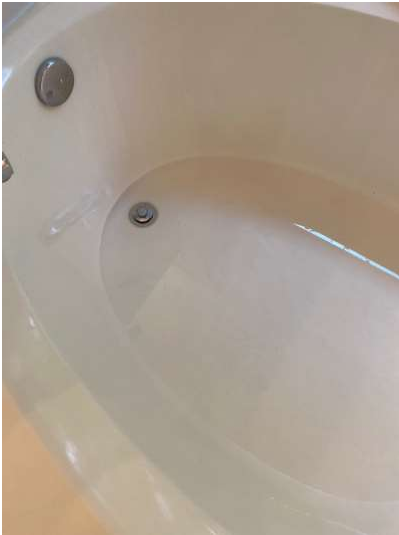
*Slow to drain - bathroom #2*

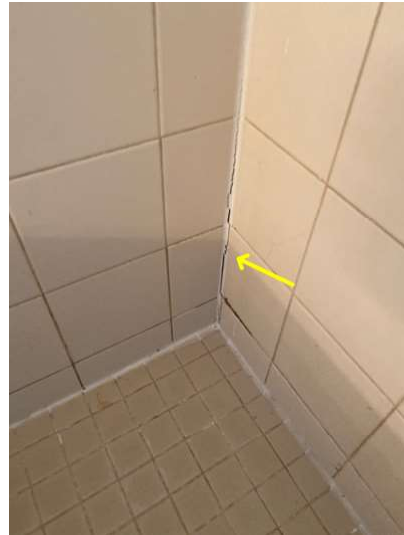
*Caulking deterioration - bathroom #2*

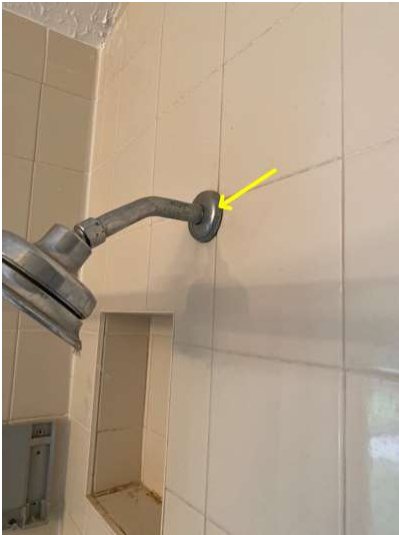
*Loosely attached - bathroom #2*

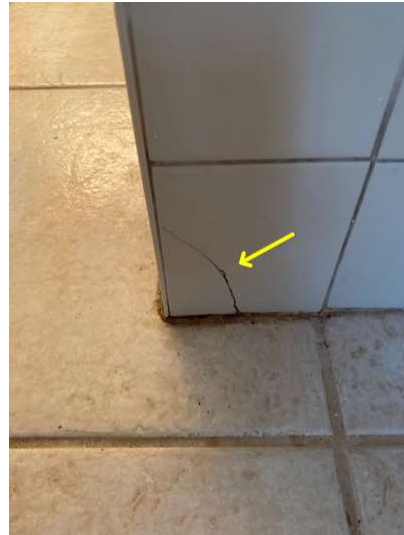
- Tile is cracked on side of tub in bathroom #2. It is recommended to be properly repaired or replaced as needed.

*Cracked tile - bathroom #2*

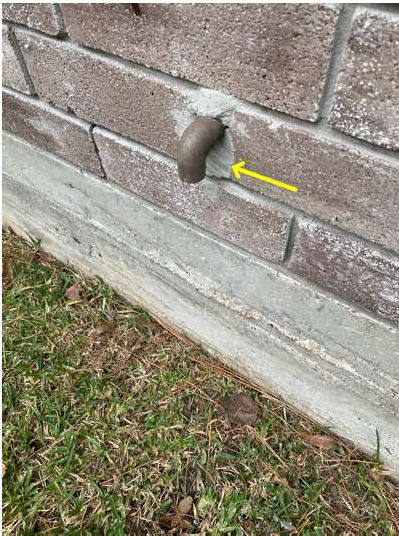
- TPRV (temperature & pressure relief valve) drain pipe should be terminated to exterior less than or equal to 6" from the ground and not threaded. It is recommended to properly repair as needed.

*Too high*

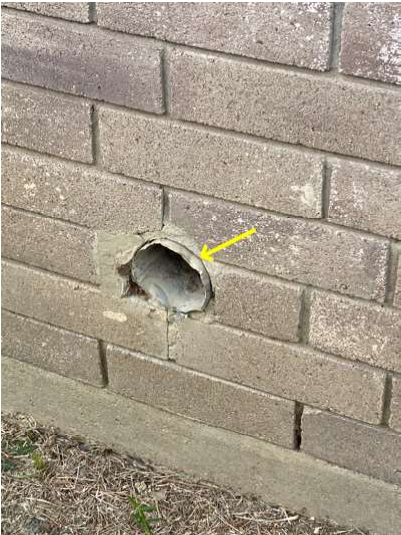
Missing cover
