123 Ave, Anywhere, TX  
Inspection prepared for: Sample Sample  
Date of Inspection: 10/8/2020 Time: 8:00 AM  
Age of Home: 1987 Size: 1731

## PROPERTY INSPECTION REPORT

Concerning: 123 Ave, Anywhere, TX  
(Address or Other Identification of Inspected Property)

By: Lou Wissner, License #7492 10/8/2020  
(Name and License Number of Inspector) (Date)

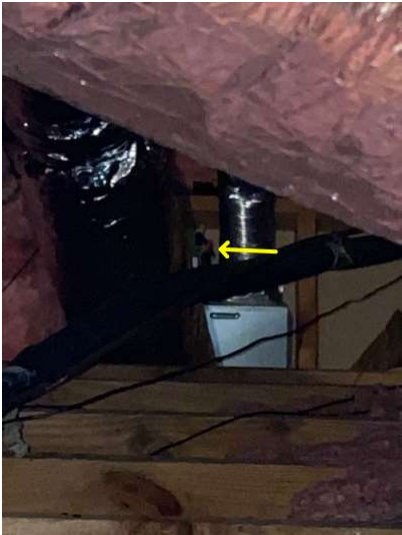
*Exposed wires*

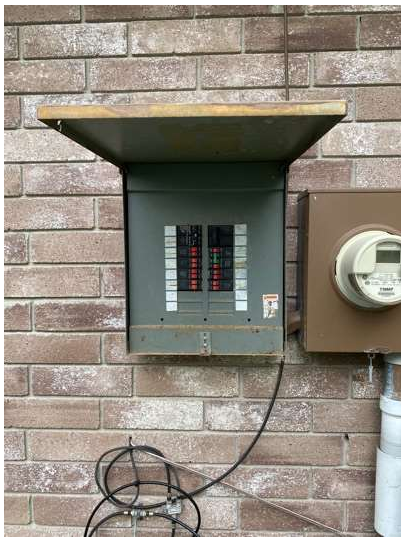
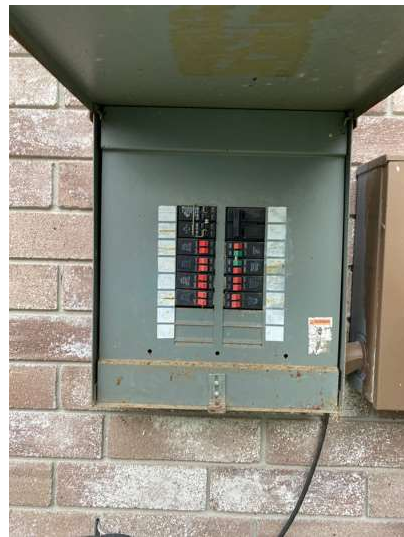
- Circuit panel is not properly or completely labeled. It is recommended to be properly labeled designating which breaker is for which circuit.
- Grounding conductor is loosely attached at ground rod. It is recommended to be securely attached to rod at acorn nut.
